Preliminary Lake Evaluation (PLE) for Willow Lake

Ownership and management: U.S. Forest Service, Lassen National Forest, Almanor Ranger District.

Location: Plumas County (40°24'14.27" N 121°21'40.03" W)

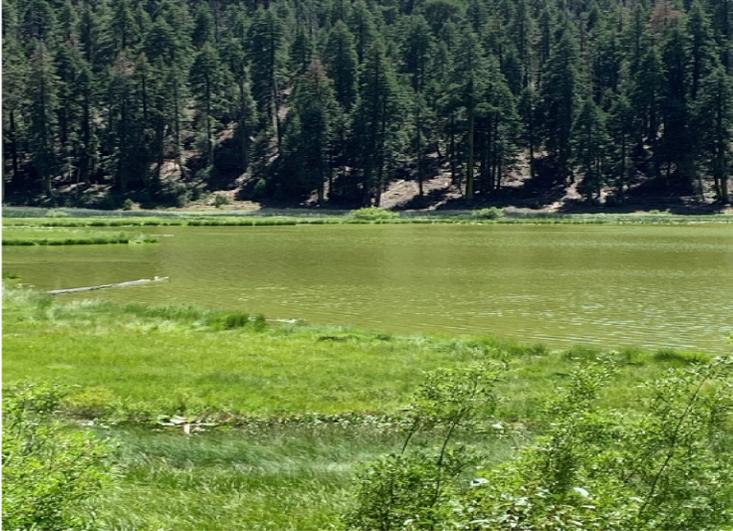
Figure 1. Willow Lake CyanoHAB bloom, July 22, 2019 (Craig Hemping)

The U.S. Forest Service, Almanor Ranger District, received a call from a member of the public (week of July 8, 2019) concerned about the color of the water in Willow Lake. US Forest Service staff visited the lake on July 15 and noticed the color of the water appeared like green pea soup. A sample was collected for jar testing (i.e., to see if cyanobacteria [was] present and floating at the surface). The jar test was positive, so the staff reached out to the Water Boards for assistance in analysis.

Forest Service staff revisited the lake on July 22 and collected two surface water grab samples. Air temperature of about 20 °C and water temperature of about 22°C at time of collection above the floating algal mat. The reported Lab results identified two genera of cyanobacteria - *Aphanizomenon* sp. and *Dolichospermum* sp. The saxitoxin gene was detected in both samples, and toxin analysis detected low concentrations of saxitoxin in each sample (0.22 ug/L and 0.19 ug/L). As far as is known, these data are the sum total of all water quality data on record for the lake.

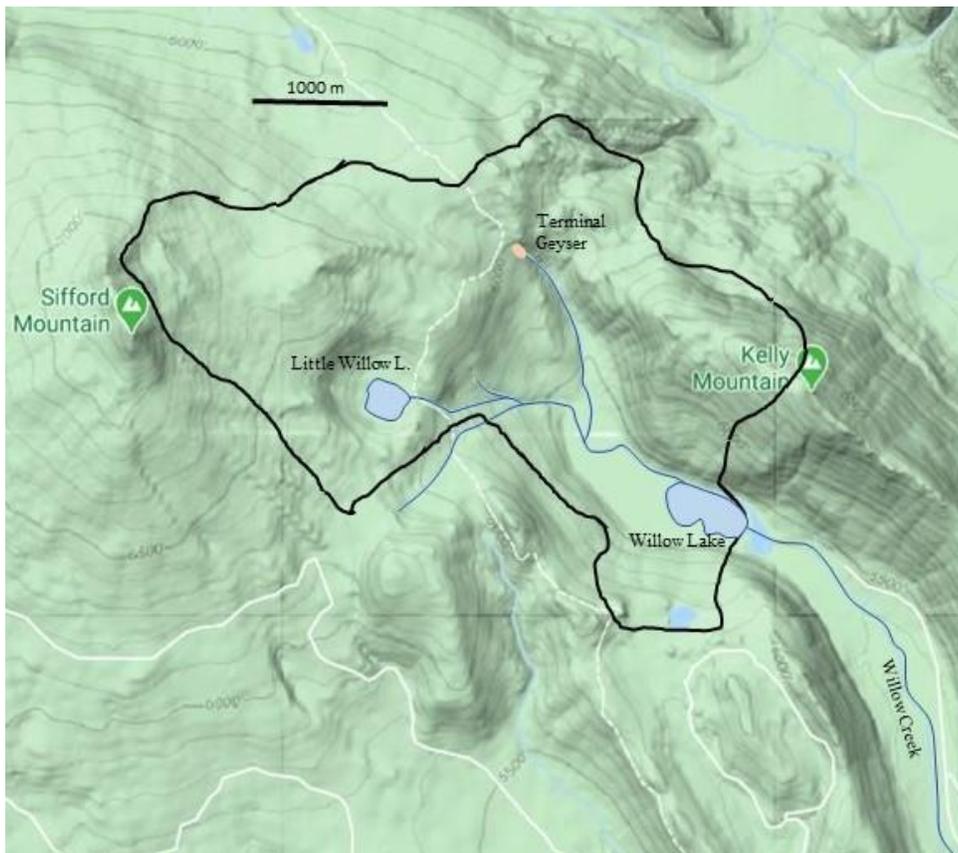
Figure 2. Willow Lake watershed

Willow Lake lies at the head of the of the Feather River watershed just 16 km (10 miles) south east of Mt. Lassen. Willow Creek flows into the North Fork of the Feather River about 10 km (6 miles) above Lake Almanor. Its own watershed ranges in elevation from 2258 m (7409 ft) at Mount Sifford to the lake surface at 1663 m (5457 ft), a drop of some 570 m (1866 ft)(Figure 2). The watershed area is about 11.4 km², (2842 acres) roughly 76 times the area of the lake surface (Table 1). There are two short streams above the lake, one stream flows easterly from Little Willow Lake about 2.4 km (1.5 miles) to

Willow Lake and the other flows southerly from Terminal Geyser and joins Willow Creek about 0.5 km (0.3 miles) above Willow Lake (Figure 2). It is not known by us if Terminal Geyser is active or not. There is another active hydrothermal pool, Boiling Springs Lake, further upstream that appears to be linked to Terminal Geyser. Water may flow or seep from Little Willow Lake most of the time, possibly as ground water feeding springs closer to Willow Lake (not confirmed).

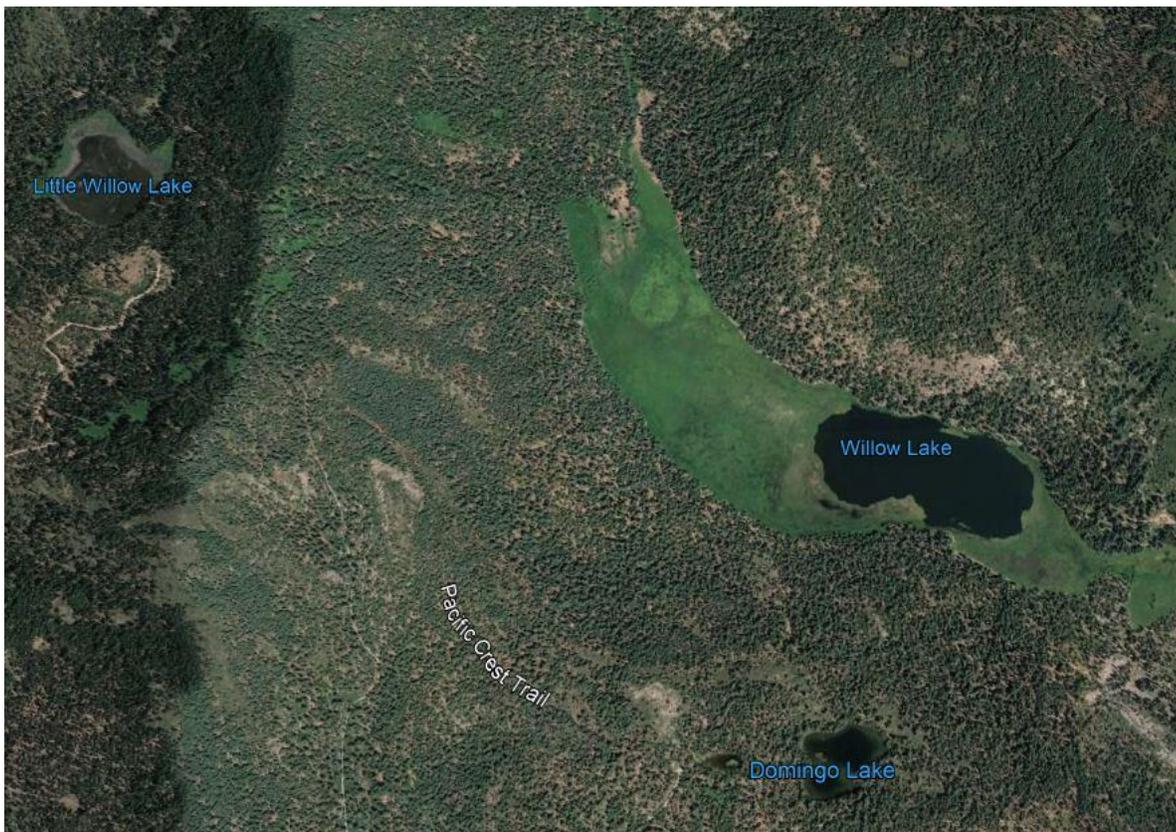
Figure 3. Willow Lake satellite image taken on 7/2/2017. The sphagnum wetland upstream to the left of the lake is about 3.4x the surface area of the lake

Willow Lake is natural with no dam and no flow control structures or valves (Table 1). On all available historical Google earth images, Willow Lake appears as a consistently small oval-shaped lake with extensive bog/wetland like areas around much of its periphery, especially upstream and downstream (Figure 3). In addition, there are areas where floating sphagnum mats in excess of 0.6 m (2 ft) thick extend out over the surface of the lake. These mats more or less hide the true shape of the lake basin. Satellite imagery going back to 1993 show very little change in the shape and size of the open water and the extent of the wetland areas. The wetland area upstream of the lake is about 3.4 times the size of the open lake area. Willow Lake has a maximum length of 661 m (2169 ft) and a maximum width of 284 m (931 ft), with a shoreline of 1.8 km (1.2 mi). It sits at an elevation of about 1663 m (5457 ft). Based solely upon examination of contour maps of the valley, the lake appears to be quite shallow, perhaps less than 2 m (6 ft) deep. For calculation purposes we assumed the mean depth is half the estimated maximum depth, or 1 m (3 ft) deep. The surface area of 0.15 km² (37 acres) was based on the open water area up to the edge of the floating sphagnum mats. The estimated volume of 150,000 m³ was calculated by multiplying surface area by mean depth. With a watershed area of 11.4 km² (2842 acres), it is about 76 times the area of the lake surface. Given the frequent large snow packs, it should not be surprising if an intense rainstorm or unusually warm weather could rapidly melt snow and basically flood and flush the lake with, perhaps, radical changes to the water chemistry.

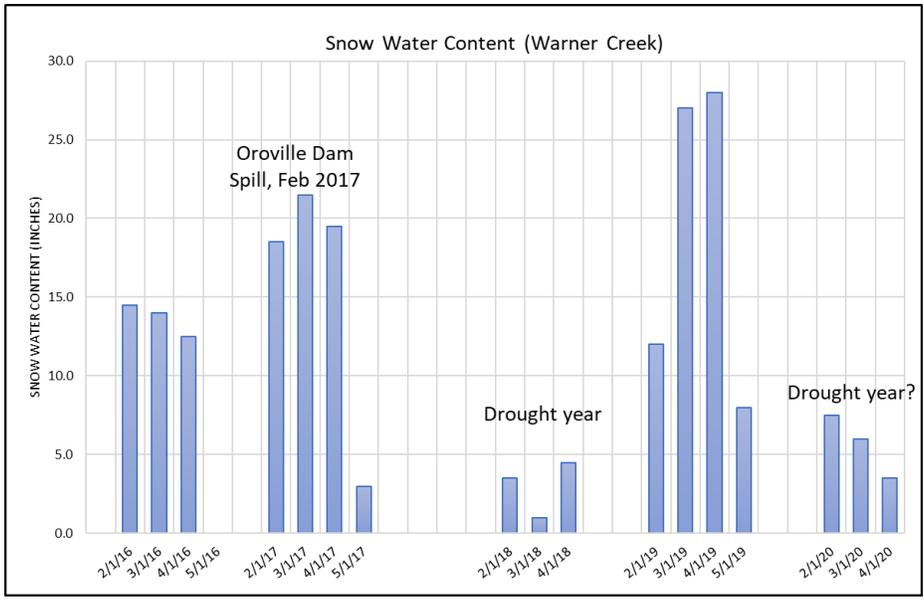
Figure 4. Snow Water Content at the Warner Creek (WRN) monitoring station at a similar elevation and about 1.3 km (0.8 mi) SE of Willow Lake (source CDEC). The readings were reported on the first day of each month.

Snow water content (CEDC) from Warner Creek (WRN), a nearby monitoring station, was used to evaluate hydrologic conditions surrounding Willow Lake. WRN is at a similar elevation and about 1.3 km (0.8 mi) SE of Willow Lake. Snow fall and snow water content are the only data available at that station. Snow water content, by month, is presented for 2016 through 2020 in Figure 4. Readings are taken on the first day of each month, so the value represents the quantity of snow-water present at the end of the preceding month. In years 2016, 17 and 19, most of the snow melted during April (Figure 5), which, in 2017, is contrary to the report cited above when Oroville failed due to flooding in February. This may have been due to local variations in weather patterns in the small Willow Lake watershed which is 100 km (62 air miles) from Lake Oroville. The years 2017 and 2019 were exceptionally wet while 2018 and projections for 2020 indicate severe drought years.

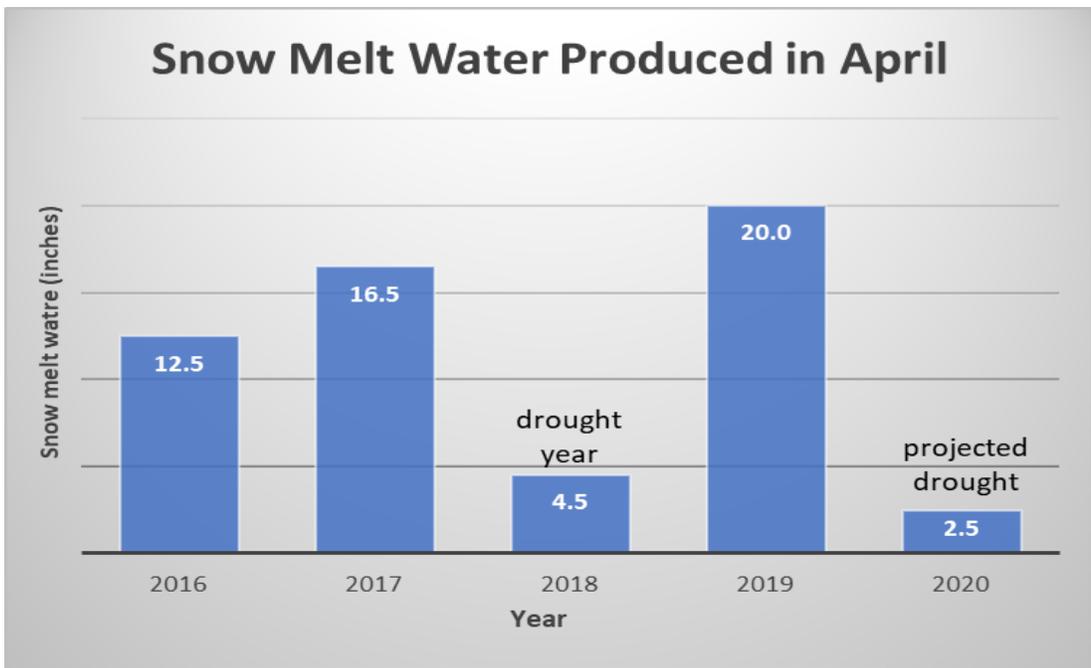
Figure 5. Snow melt water produced during the month of April from 2016 through 2020 based on Warner Creek station (WRN) data (CDEC). Values were calculated by subtracting snow water content on May first of each month from snow water content on April first of each year (Figure 4).

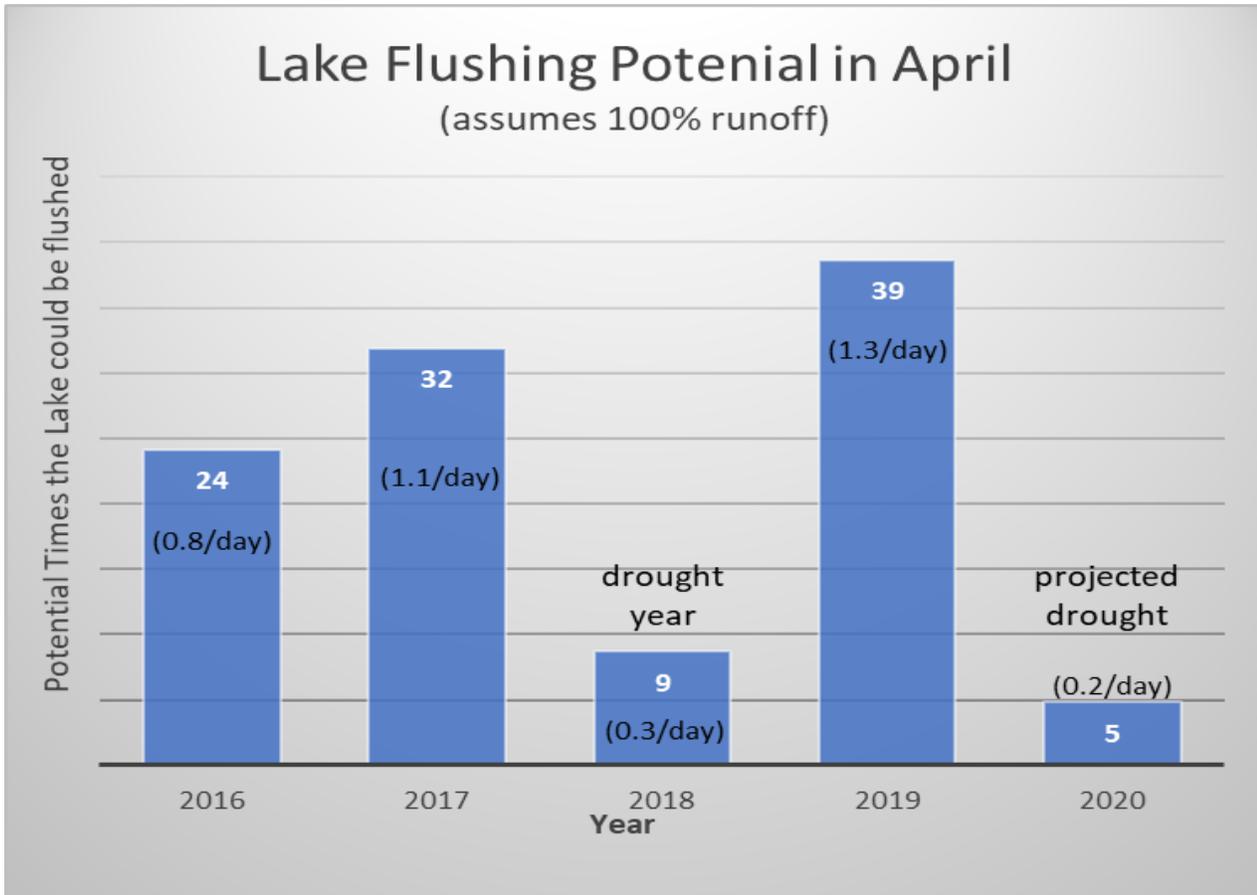
Figure 6. Potential number of times Willow Lake could have been flushed during April of each year assuming saturated soils and 100% runoff of melt water.

Assuming saturated soils, there was enough snow melted during April 2016, 2017 and 2019 to flush Willow Lake 24, 32 and 39 times, respectively, or 0.8, 1.1 and 1.3 times each day of the month if the melting was uniformly distributed during the month, (Figure 6). The water quality consequences of this much water passing through this system are worthy of further study. The buffering capacity of sphagnum beds is considerable, but normally they are fed by lower drainage rates as seepage and springs through the soils. Overland sheet flow was possible during 2016 and most likely in 2017 and 2019 sometime in April.
